## Quantum Chemica compressor monitor

by Tim Smith
Assistant Superintendent
Reliability Maintenance
Quantum Chemical, Morris Plant
Morris, Illinois

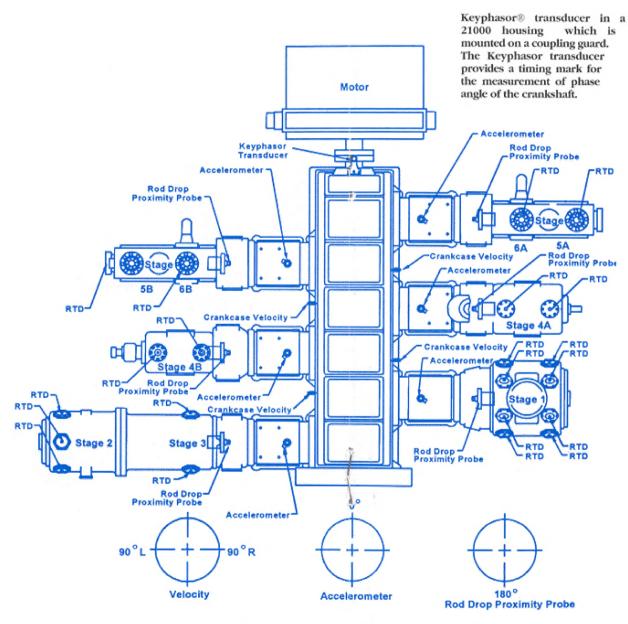
Machine train diagram, showing transducer locations.

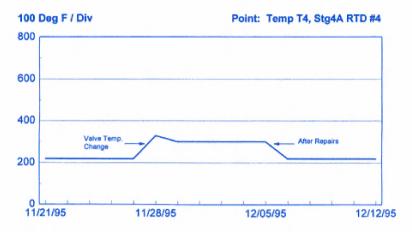
Figure 1
Trend plot of discharge valve temperature

Trend plots (Figures 1 and 2) indicated an increase in temperature on both the suction and discharge valves on the fourth stage cylinder of one of the large ethylene reciprocating compressors. The temperature had increased from 60° to 113°C (140° to 235°F) over a 24 hour period on the discharge valve, and from 38° to

102°C (100° to 215° F) on the suction valves. These valve temperature trends, which indicated valve problems on the fourth stage, were trended on the TDM2 System. We were then able to plan the shutdown and to replace the valves during a scheduled outage. The used valves revealed that the discharge valve disc had broken into three pieces and the suction valve was almost completely plugged. (See photos of broken valve disc and plugged suction valve.)

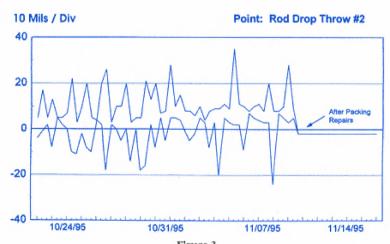
Figure 3
Trend plot showing rod movement on the compressor

Figure 3 is a trend plot of the rod drop on the first stage of the same compressor. Shortly after the compressor startup, the TDM2 System indicated a rod drop alarm on this cylinder. The trend plot indicated a large amount of rod movement. The compressor was shut down during a scheduled outage. We found that one of the three packing hold down studs had backed out, and the packing had come loose. Without the Rod Drop Monitoring System, we would not have known about this problem. Early detection of the loose packing prevented the entire packing gland from coming loose in the crosshead area. This prevented a long-term outage that could have resulted in extended downtime and high maintenance repair costs.
